**USGS National Groundwater Monitoring Network Cooperative Agreement  
Final Technical Report**

**Award Number:** G17AS00009

**Title:** Missouri Department of Natural Resources' Missouri Geological Survey proposal to reconstruct three existing observation wells in order to prevent shallow water from entering the well.

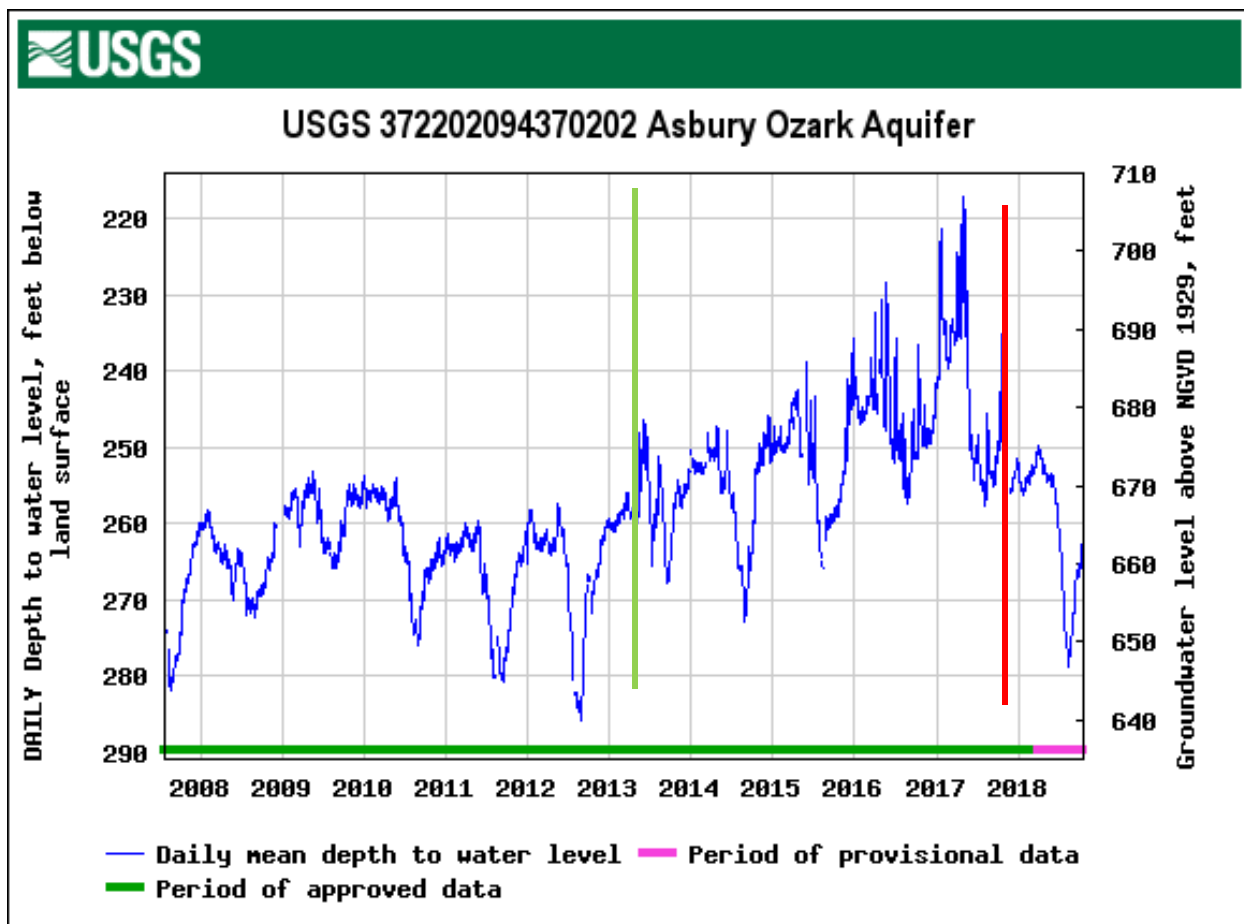
Following reconstruction of these wells the water level returned to what is believed to be the normal level. The hydrograph below from the Asbury well shows a gap in the data near the end of 2017 marked by the red line. This was when the well was offline for repair. After the project successfully sealed out the shallow water, the water level in the well returned to the level prior to the formation of the hole. Based on the hydrograph, it is estimated that the hole began developing in mid-2013 (marked by the green line) and gradually got larger. This is based on the larger fluctuations in the graph which also correspond to precipitation events. Prior to 2013 the water level was never above 250 feet. Since the repair the water level has once again dropped below 250 feet.

The actual well repair process involved installing a 2" PVC liner from the surface to the total depth of the well with the bottom portion slotted for water movement, packers were installed along with the liner and rest just below the bottom of the existing casing, and the liner was grouted to prevent the shallow water from entering the borehole or annular space. This process effectively sealed the existing hole and any future holes that may occur in the casing.
