# Well Maintenance at South Carolina NGWMN sites and Expanding the South Carolina Groundwater Monitoring Network

Final Technical Report

Award Number G19AC00182

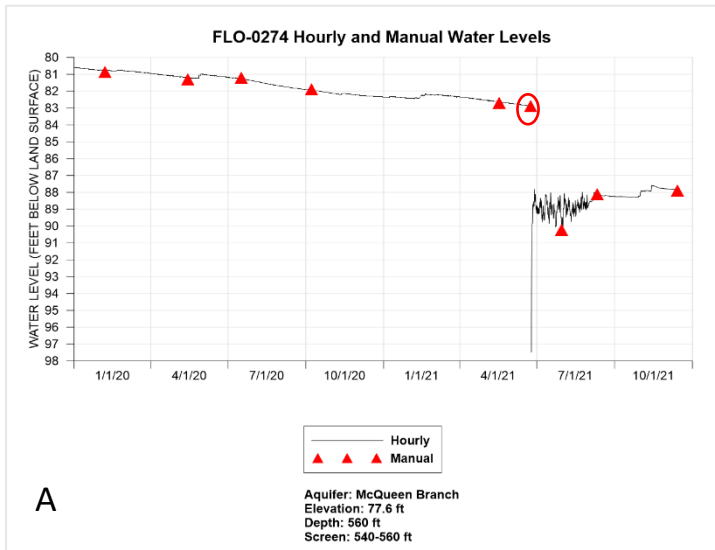
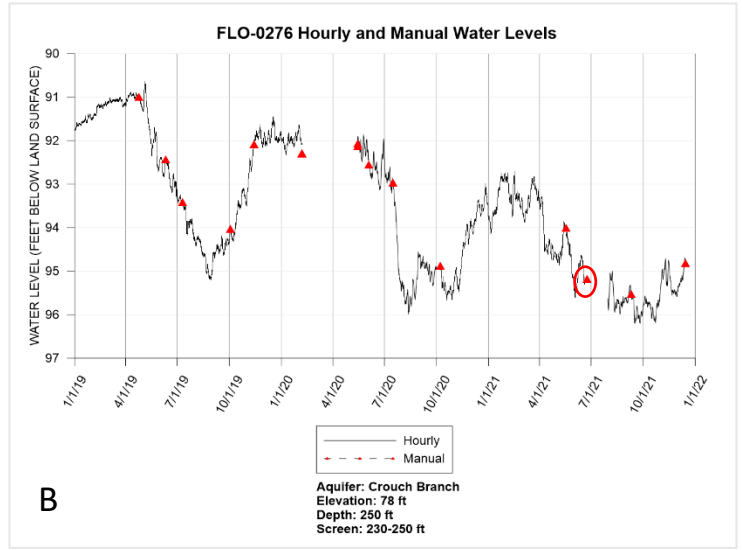
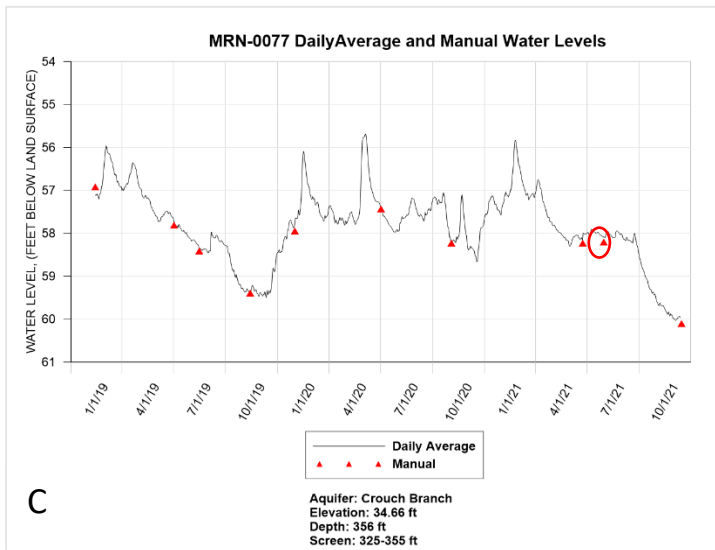
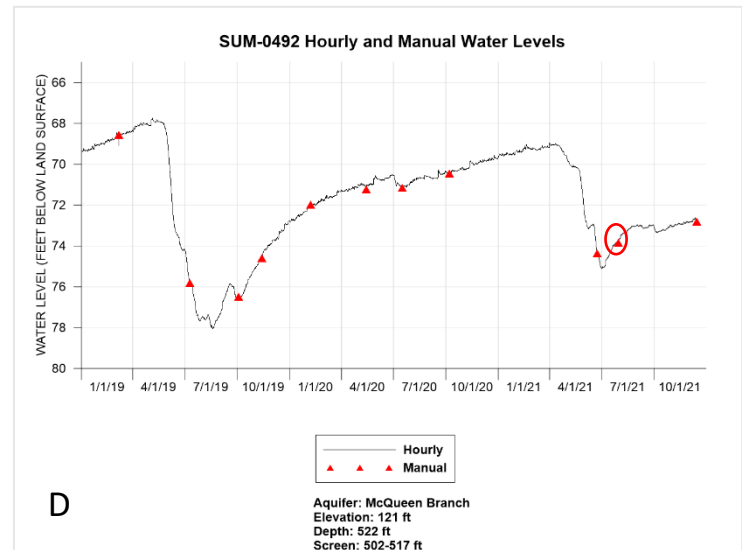
Three wells, (FLO-0276 – 16Q-s1; MRN-0077- 10Q-p1; SUM-0492 – 24Q-l2) pumped smoothly and are considered well connected to the aquifer in which they are completed. The McQueen Branch well (FLO-0274 – 16Q-s1) would not yield water after several attempts. The water level dropped below the pump intake within the first minute of pumping. The well did not recover after several minutes. We returned to the well the following day and the water level had risen approximately 9 feet after 21 hours. Due to time and equipment constraints with the contractor, we were not able to attempt pumping again. Also, lowering the pump was not an option. It is suspected that this well is that the well screen is clogged with sediment, the screen is not in the correct location, or the casing is damaged. SCDNR plans to inspect this well with a down-hole camera to identify problems and then re-develop it with air. This well has been taken off-line in the NGWMN Registry until the problem can be identified and fixed.

Figure 3A-D shows two-to-three-year hydrographs of the wells pumped for this project. This period was selected to identify changes that may have occurred from pumping the wells during a period before and after pumping. With the exception of FLO-0274 (Fig. 3 A), water level in the wells recovered quickly (within several minutes). Loggers were re-deployed immediately and programmed to begin logging during the same day. Hydrographs of the three successfully pumped wells show similar water level trends and fluctuations (short and longer term) when compared to the shown period of record before pumping. A gap in the record at FLO-0276 (Fig. 3 B) occurred directly after pumping because the logger was not programmed when it was returned to the well.

Figure 3 A-D. Hydrographs of wells pumped for Objective 4. On each graph, the manual measurement (red triangle) with red circle is the manual water level collected immediately prior to pumping well.
