Award Number: G19AC00180

New Mexico Bureau of Geology and Mineral Resources (NMBGMR), at New Mexico Tech
New Mexico Bureau of Geology and Mineral Resources groundwater level monitoring network
Year 3

Date: March 4, 2021

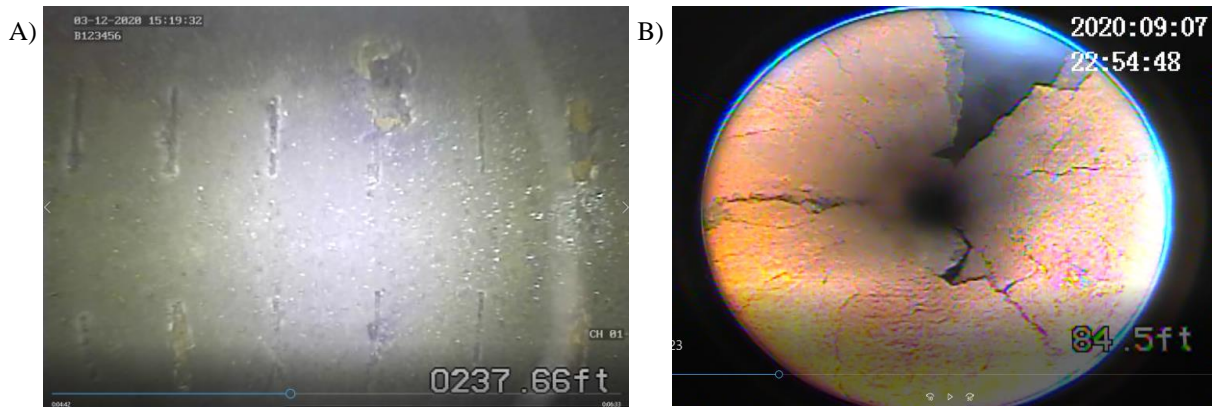
Figure 3. Examples of well images and data captured with down-hole cameras. A) Small (about 0.2 feet in length) slots in well screen in SA-0174 (side-view camera) imaged using the Laval Underground Surveys R-Cam Model 1000 XLT. B) Holes and cracks in TB-0203 casing imaged using a Well-Vu DVCC15 equipped with a single wide-angle Fisheye camera. The deteriorated state of the casing and low amount of water remaining in the well lead to its removal from the NGWMN.
