AGENCY: Maryland Department of Natural Resources, Maryland Geological Survey

PROJECT TITLE: Filling Gaps in Information and Performing Well Maintenance at MGS NGWMN sites

FINAL REPORT DATE: September 25, 2019

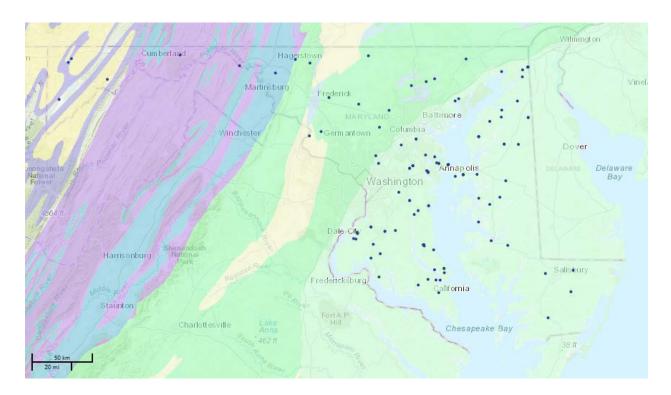
A total of 112 wells are included in this project, 90 in the coastal plain and 22 in the fractured rock aquifers of Maryland (fig. 1).

Figure 1. Map of NGWMN wells in Maryland

For Maryland's network of NGWMN wells, all 112 wells (fig. 1; App. A) were lacking metadata related to lithology and 36 wells were missing one or more types of well-construction data. We compiled the available missing data primarily from Maryland State well completion reports, which are required to be submitted upon completion of well construction. From the well completion reports we were able to determine lithology by depth interval from the driller's log. In addition, well construction data elements (well depth, and casing and screen diameter, depths, and material types) are listed in the reports and were compiled for this project. Some of the monitoring wells were originally drilled as part of MGS or USGS scientific studies, and thus have lithology (and hydrostratigraphy) that has been interpreted to a more professional level. If these data existed, they superseded the data found on drillers' completion reports. Many of the wells were constructed prior to the requirements for well completion reports to be filed upon construction or otherwise lacked documentation in Maryland files. As such, there were 16 wells for which a completion report or agency technical report could not be located or does not exist to provide data to fill an information gap for lithology or well construction.
