**Information Gap Filling and Continuing Operations
for the Maine Groundwater Level Monitoring Network, 2018-2021**

Final Technical Report for NGWMN Award Number G18AC00079:
September 1, 2018 – February 28, 2021

Maine Geological Survey
93 State House Station
Augusta, ME 04333-0093
Telephone: 207-287-2801

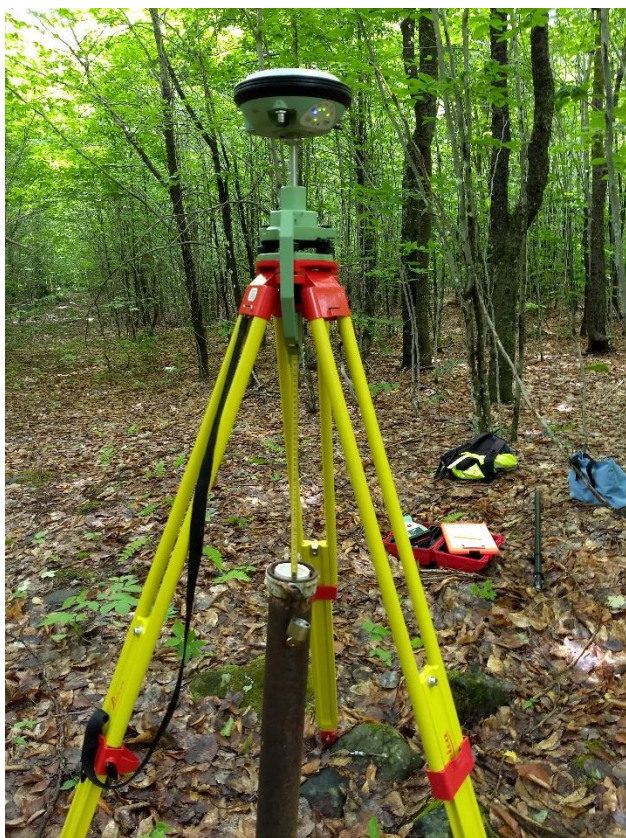
Figure 1. The GNSS antenna collecting GPS data and RTK correction information, mounted on a tripod over the measuring point of well number 40460 in Milo, Maine.

(vertical) datums. The GNSS equipment consisted of a Leica GS14 smart GPS antenna mounted on a leveling rod or tripod and a Leica CS15 field controller (Leica Geosystems AG) (Figure 1).

At 26 of the 29 surveyed wells, cellular data connections were available and the GNSS system was able to use real-time kinematic (RTK) correction using base station information from the Continuously Operating Reference Station (CORS) network maintained by the Maine Department of Transportation. The RTK corrections allowed us to collect precise locations with an average accuracy of 2 cm horizontally and 4 cm vertically. Three of the 29 surveyed wells were outside the reach of a cellular data connection. At these locations, we performed a static occupation of the site with the GNSS system, collecting dual-frequency GPS carrier phase observables that were later uploaded to the NOAA Online Positioning User Service (OPUS) for post-processing correction. At 2 wells (41176 and 100408), the OPUS correction was successful, resulting in average accuracy of 10 cm horizontally and 6 cm vertically. At well 40412, heavy tree-cover in a small stream valley made the GPS data too noisy to correct with OPUS. At this location, the uncorrected GPS accuracy was 2.1 m horizontally and 2.9 m vertically.

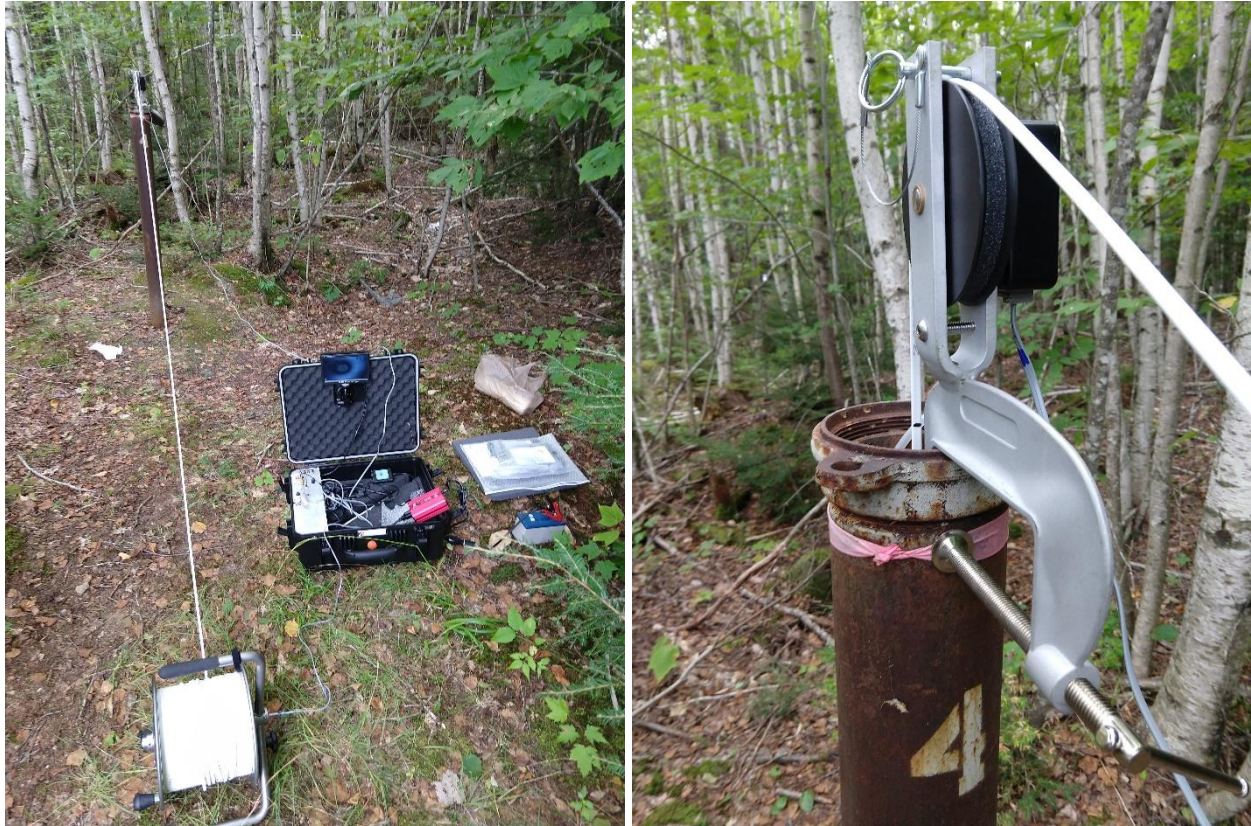
Figure 2. (Left) The video camera system set up at well 40496 in Greenbush, Maine. (Right) The depth encoder and cable positioned over the measuring point at the top of the well casing. The camera is inside the casing, with the lens three feet below the measuring point.

In Year 2, we visited 12 of the wells that had been visited in Year 1 to record color digital videos of the well casings, screens, bores, and bottoms. The video system consisted of a submersible GeoVISION Nano Camera (Alleghany Instruments, Inc.) suspended on a graduated cable with a digital depth encoder (Figure 2). For this task, we prioritized wells that lacked information about the casing or screened interval, and bedrock wells where lithologic logs were unavailable, followed by wells for which the screen material and size were unknown.

Among the 12 wells that were visited were all the wells in our network where the casing and screen intervals were unknown, and all bedrock wells that were missing lithology information. At each well, we set up the camera so that the lens was positioned three feet below the monitoring point, zeroed the depth counter, then began recording video while lowering the camera slowly to the bottom of the well. At interesting or ambiguous locations, the camera could be raised and lowered repeatedly to get better views of the casing, screen, or bore. The videos were saved as mp4 digital video files, and the depth encoder printed the camera depth in feet at the corner of the videos, so that the depth of observed features was recorded. By taking notes in the field and watching the recorded videos later in the office, we were able to use this system to record the depths of casings, screens, and lithologic features, and to observe the screen material and size.
