USGS National Groundwater Monitoring Network Cooperative Agreement Final Technical Report

Title: The Missouri Geological Survey proposal to perform maintenance

on the Wildwood Observation Well.

Description of Wildwood Remediation Project

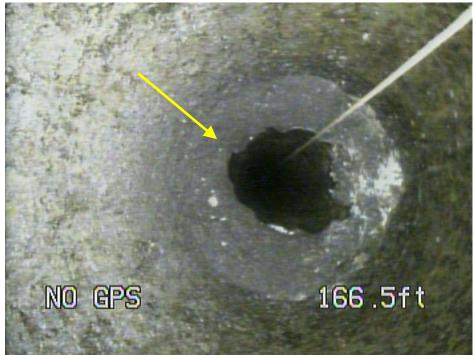
The Wildwood groundwater observation well was drilled in 2008 to a depth of 445 feet and has 166 feet of casing. The well monitors groundwater levels in the upper portion of the Ozark Aquifer from water residing in the St. Peter Sandstone. Downhole camera inspection, funded by previous NGWMN grant, revealed a blockage at the bottom of the casing which prevented groundwater monitoring equipment from being removed from the well and maintained.

Wildwood well blockage

On June 22, 2021 contractors arrived at the site to commence activities to remove the blockage. After the project was completed, staff conducted another video inspection to document that the obstruction had been removed (see video screen shot below). Monitoring equipment was reinstalled and the site was back on line later that same day recording and transmitting water level data.

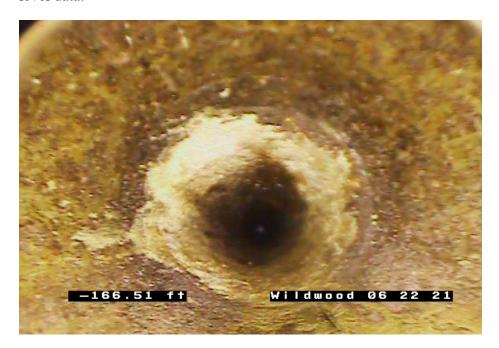
Wildwood well after blockage removal

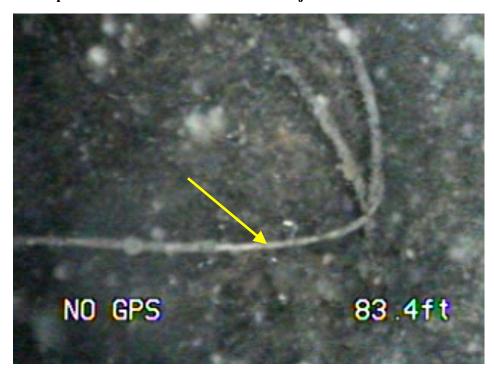
Debris in Akers well

MGS staff conducted field work to remove debris in the Akers well. A devise was lowered into the well that "snagged" the debris which could then be pulled to the surface and removed. After removal, the debris was identified as old monitoring equipment cables that had been dropped and lost down the hole. After the well was cleared of debris a new downhole camera video inspection was conducted. This inspection provided evidence that this well was originally completed with 95 feet of casing, which was previously unknown. The video log indicated that the geologic formations below the bottom of the casing were highly fractured and it was evident that pieces of the formation had fallen into the well. The video log also revealed the top of the pump drop pipe at a depth of 128 feet. Rock appeared to have been dislodged from above and had become wedged in the hole alongside of the pump pipe. While the total depth of the well is reported to be 425 feet, that could not be confirmed due to the pump pipe and blockage.

It was determined that while the well is not open to the total depth, it is still capable of monitoring the water level of the aquifer. The blockage prevents equipment from being lowered deeper into the well, but does not prevent communication of the water from above and below the blockage. At this site the Ozark Aquifer extends from the surface to an approximate depth of 500 feet. Water levels have been recorded at this site since 1971 and have never dropped below 68 feet. Therefore the blockage at 129 feet should not cause a problem with the continued used of this well to record water level changes in the Ozark Aquifer.
